А.А.Гусев.

Подборка иллюстраций и литературных ссылок и цитат по вопросу дифференциальных осадок/просадок оснований как причин повреждений и разрушений зданий  
22.01.2012.

Это быстрая и в общем почти случайная подборка легкодоступных иллюстраций и цитат по вопросу опасности от дифференциальных осадок оснований зданий и сооружений при землетрясениях. Просьба иметь в виду, что часто данное явление идет под рубрикой «разжижение грунта» или «потеря несущей способности грунта». Аналогичный характер имеет опасность от боковых сдвигов сооружений как целого, поверх грунта или вместе с грунтом.

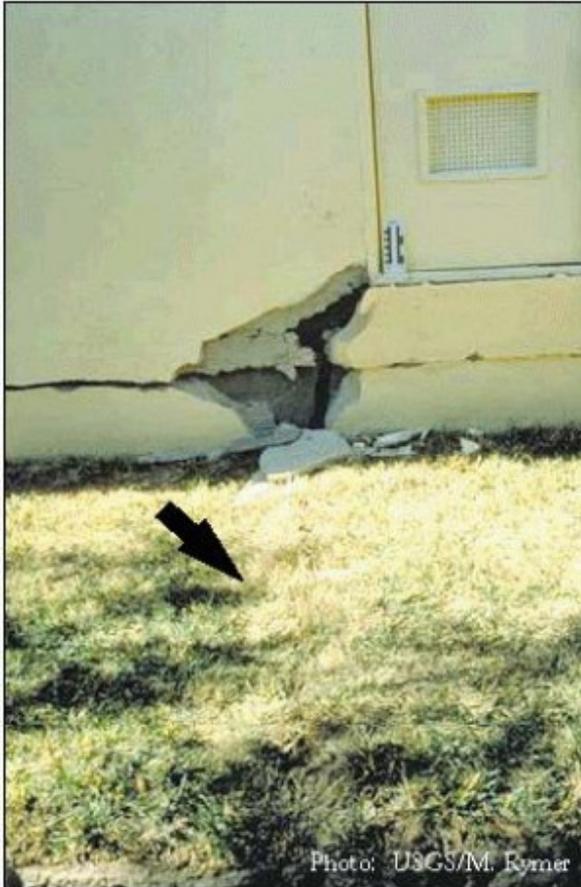
*The foundation slab of this 1-story single-family home in the Balboa Blvd. area was damaged by small settlement and extensional ground cracking that is evident in the lawn (arrow, foreground). Structural damage to the foundation was so extensive that the home had to be demolished.*

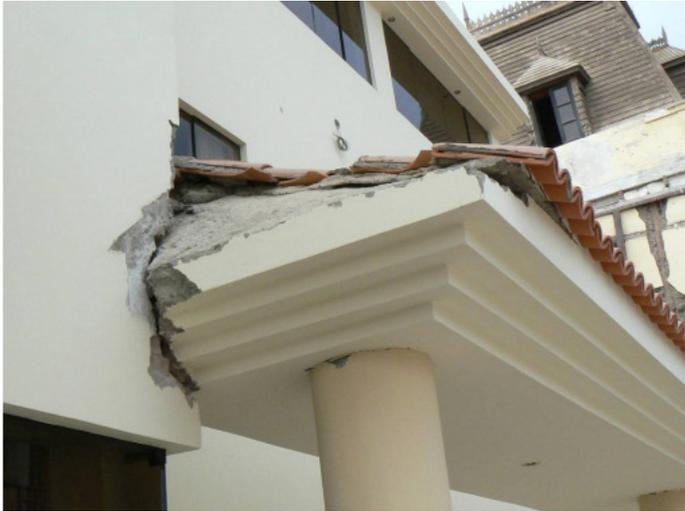
*Fig. 3.23. Close up of hotel damage. Relative ground movement, due to liquefaction, between the columns of the exterior roof structure and the building, caused the cracks.*

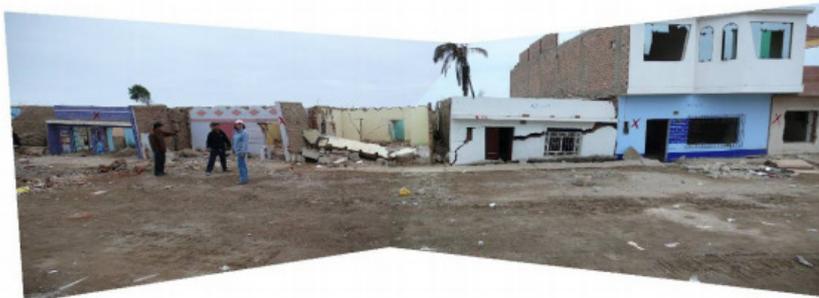
*Fig. 3.25. Settlement of 0.7 m of building in front of palm tree.*

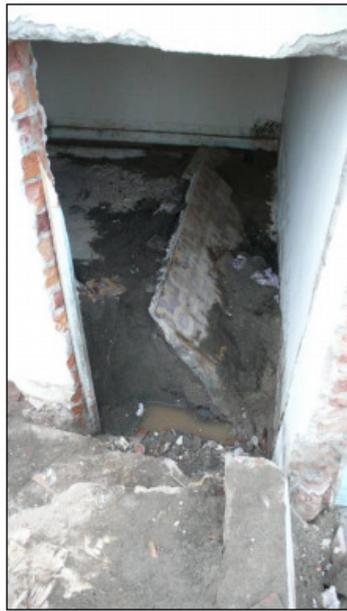
*Fig. 3.28. Foundation pushed up due settlement the building.*

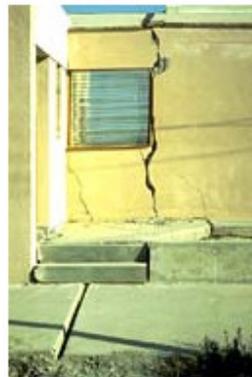
**J16.** One-story masonry house in a main housing development in the town of Cauce, damaged due to differential settlement caused by liquefaction in the 1977 Cauce Earthquake.

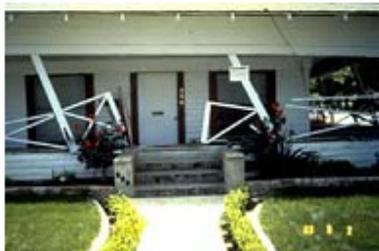
**J20.** This one-story wood frame dwelling slid on its foundation by approximately 1.0 m during the 1983 Coalinga Earthquake.

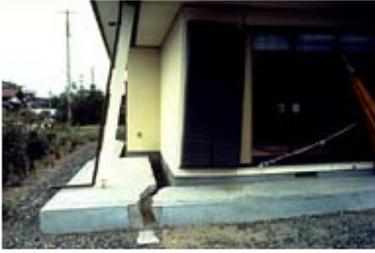
**J42.** Damage to foundation of a house in the town of Wakami, Akita Prefecture in Japan during the 1983 Nihonkai-Chubu Earthquake [10, 11]. Damage was due to lateral ground spreading of loose saturated granular soils and inadequate reinforcement of the foundation tie beams.

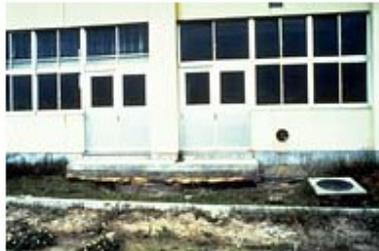
**J45.** Oga Technical High School, 1983 Nihonkai-Chubu Earthquake. Reinforced concrete door steps, cantilevered from RC grade beams supported on the pile caps illustrate clearly the significant settlement of the soil due to liquefaction.

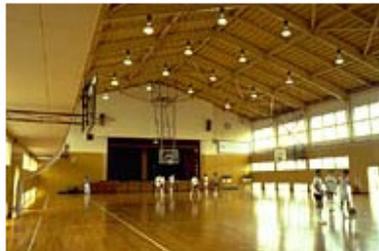
**J46.** Oga Technical High School, 1983 Nihonkai-Chubu Earthquake. Because it was constructed on properly designed pile, this gymnasium did not suffer any damage in spite of the fact that the ground soil liquefied and settled in some places by 0.50 meters (see Slides J18, J44 and J45).
